Repair on New Gen GTO Bumper

by Chris Winslow

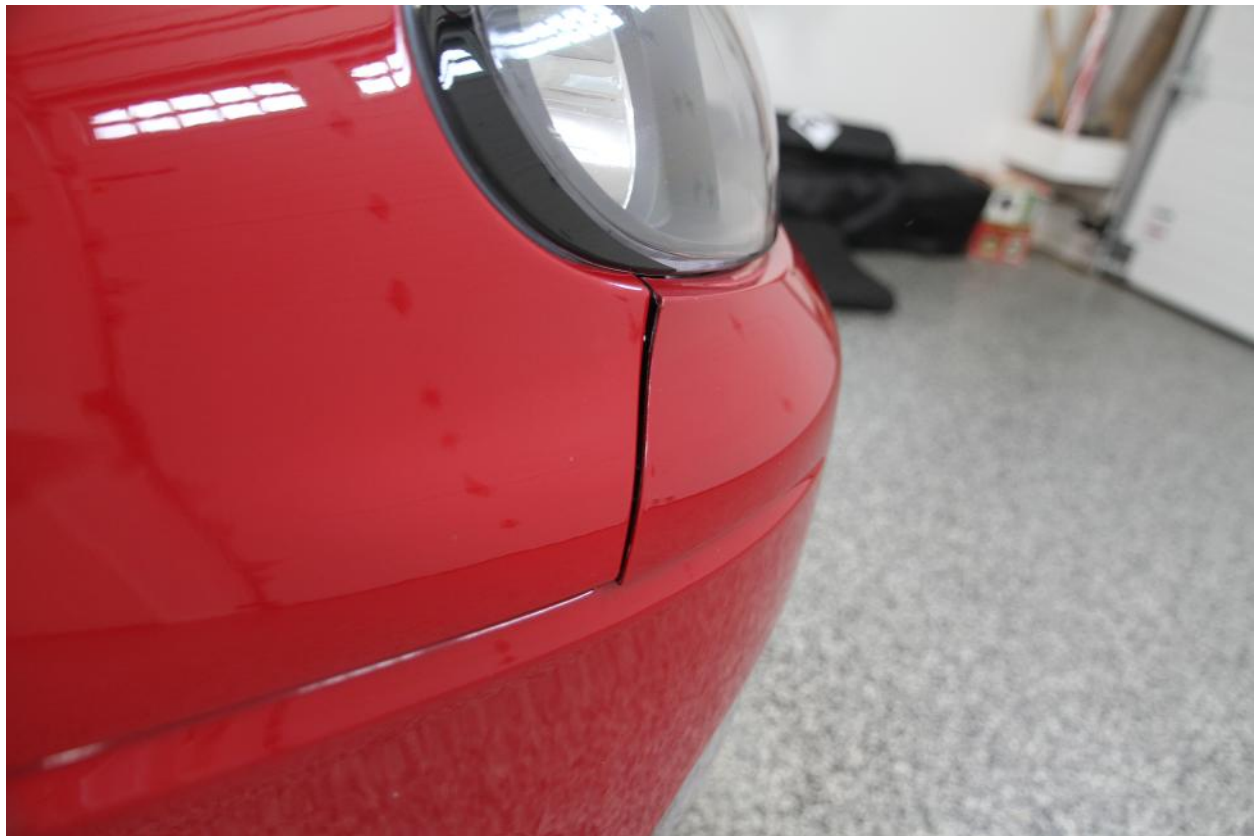
Unfortunately, the tabs, particularly the ones that clip into the bracket at the leading edge of the fender, are a bit fragile and tend to get broken if the bumper is removed for any reason. Once broken, they can be difficult to get fixed.

In my case, my tab on the passenger side has been broken for a number of years. I had tried a few years ago to fix it with a combination of some 3M epoxy and a home made bracket secured with some rivets. Unfortunately, that repair did not work. The photo above shows what it looked like after that repair.

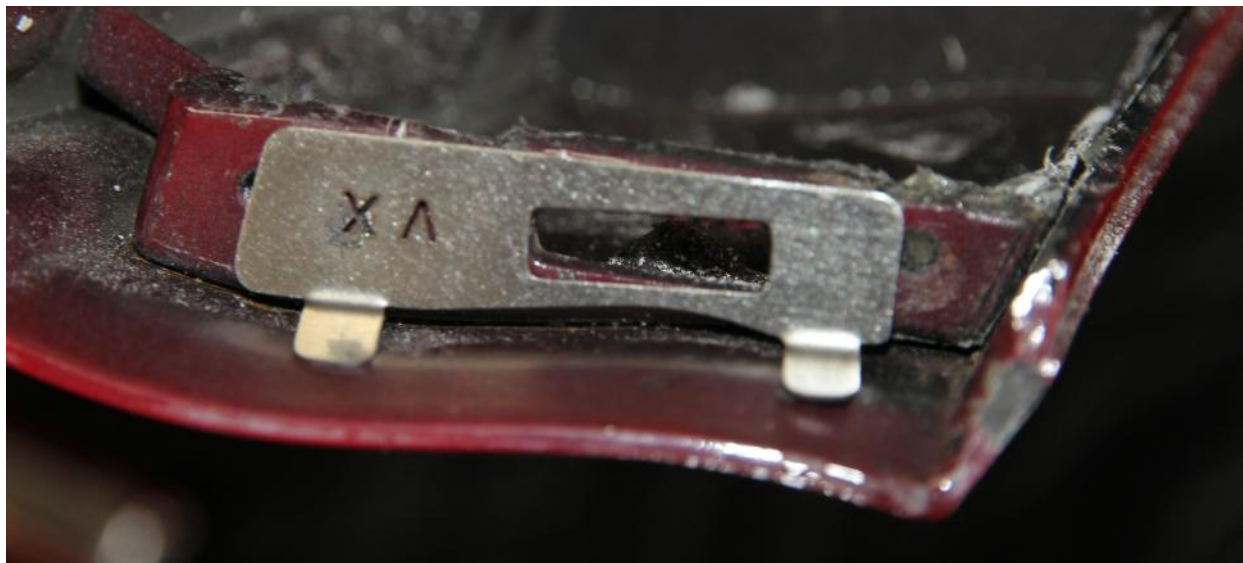
in this photo is that the tab on the bumper is actually broken on the left side of the hole. So, this repair plate will provide a means to re-secure that tab in the original location and hold it firmly in place.

The plate includes tabs for extra stability and strength of the repair, so I bent those just slightly so that they were contacting the inside of the bumper cover. What does not show well

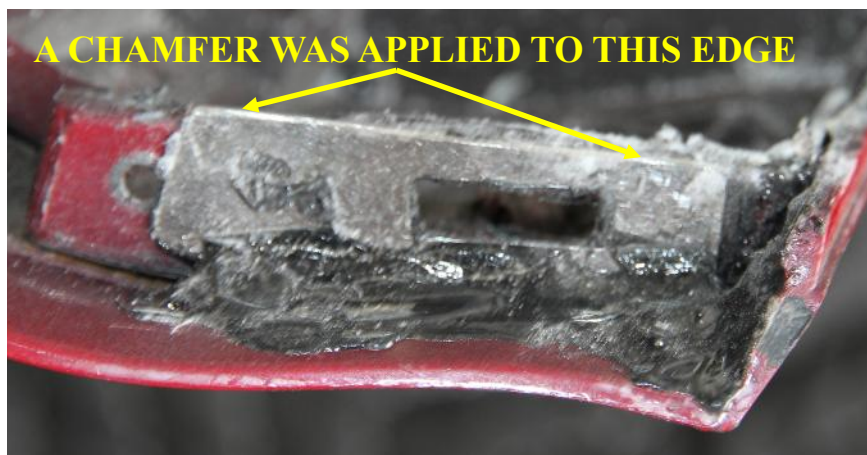
The resulting repair was actually not very pretty. I think if I ever do it again, I might try a different application method.

With the part dry fitted, I did some light sanding to rough up the surfaces and then cleaned everything with the acetone. Next up was to mix up some of the JB Weld. You would think the dual syringe set up would make that fairly easy, but as it turns out the two parts did not initially come out in equal amounts. (I think there was an air bubble). It went better on the second attempt. I mixed the two parts with a stick (a small stick is provided with the JB Weld). I then used that stick to butter up the parts and then added more JB weld over the tabs and to form a fillet for increased strength. I then used a small clamp and a small pair of Vice Grips to hold it in place while the epoxy cured.

The material did set up rather quickly. In my case, however, I had some other projects underway and did not actually get back to installing the bumper until the next day. By then the repair plate was solidly in place on the tab.

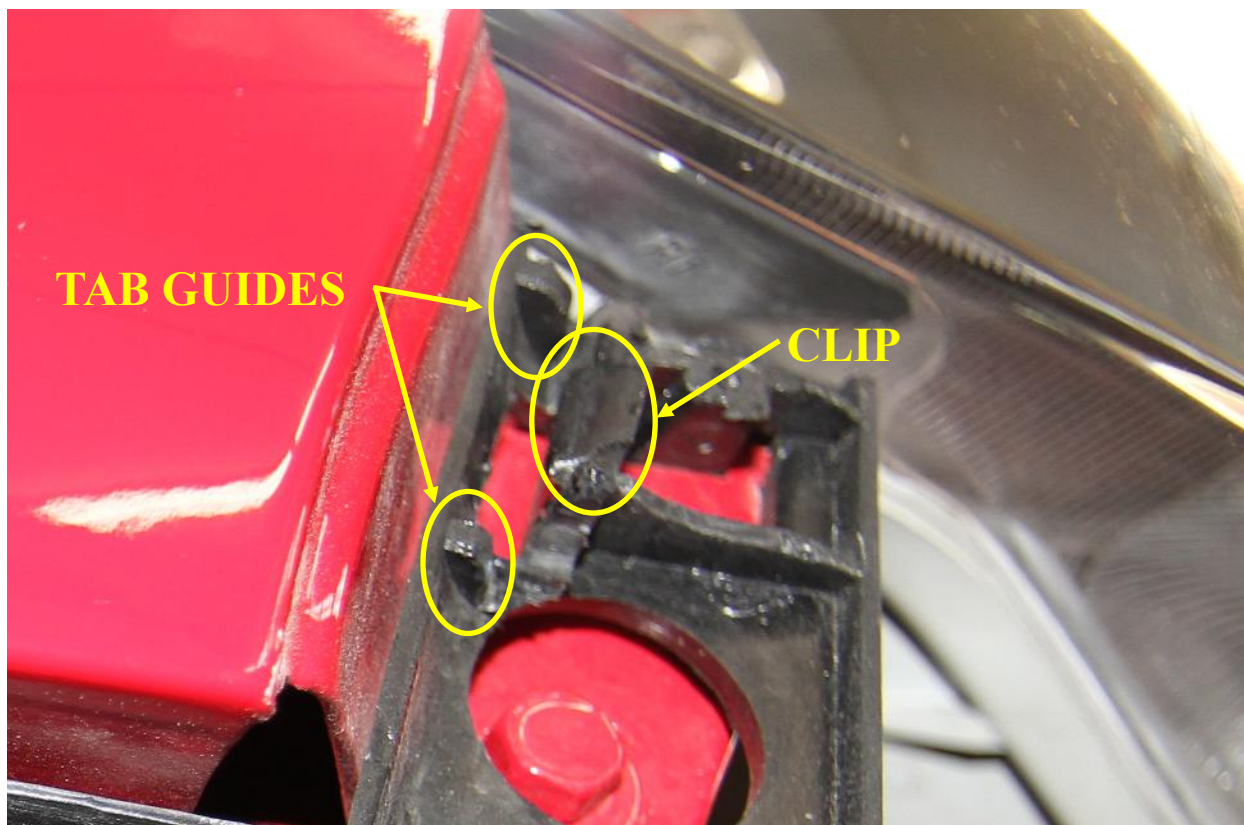
What I decided to do next was not shown in the U-Tube video. In my case, I had a spare bracket in my parts inventory so I pulled that and spent some time custom fitting it to the repaired tab. What I found was that with the repair plate in place, the thickness of the tab had increased. In addition, these repair plates appear to be laser cut. Because of that, they have

very crisp edges. That edge on the repair plate was catching the two guides that press the tab into the clip on the bracket, causing it to want to hang up on the way in. To address this, I used a file to put a bit of a chamfer on the repair plate and also slightly adjust the leading edge of the guides on the bracket.

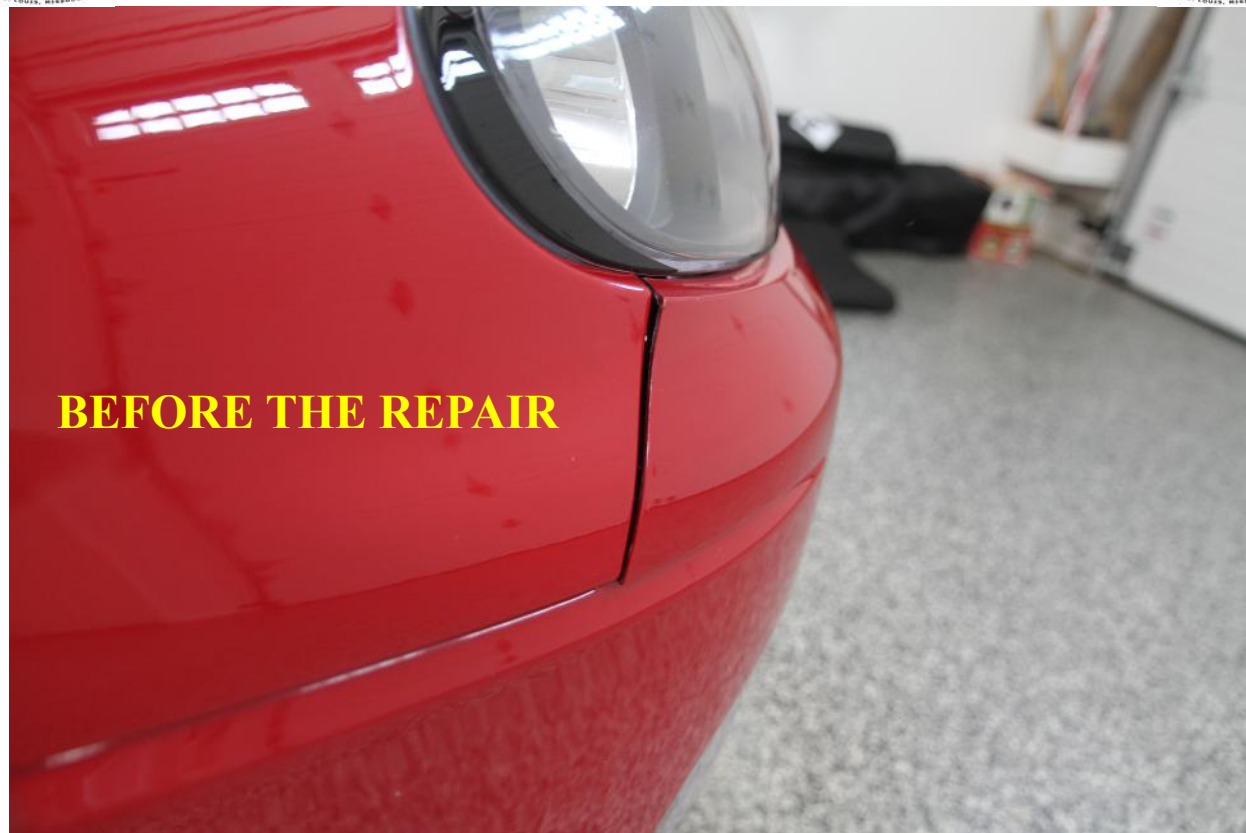
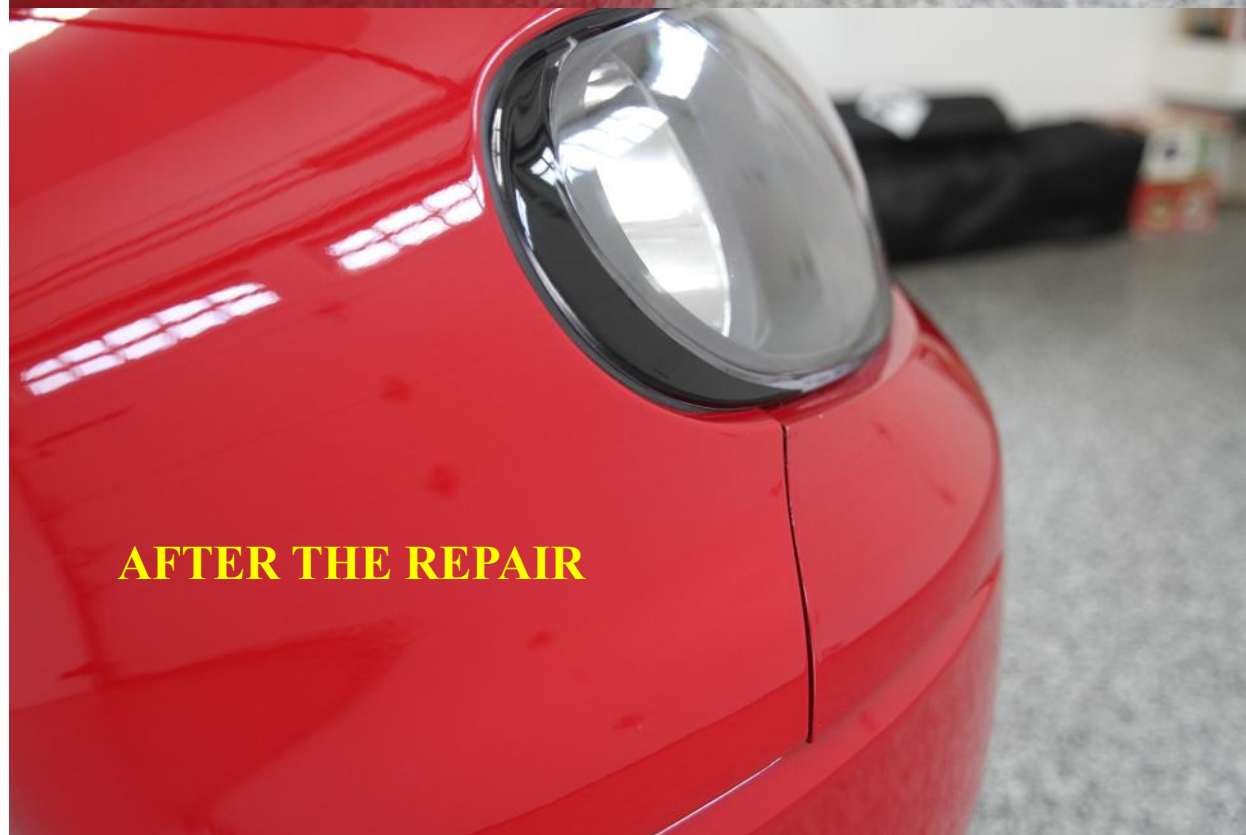
The results were excellent. For the first time in many years, that front bumper is properly in place on the passenger side of the car. See the photos on the next page for the before and after images..
